Like all TC owners, I had problems with the ride control (and other) switches in the dash. I able to get suitable working replacements over time and made the repairs. Having nothing to loose, I started looking at one of the bad ones.

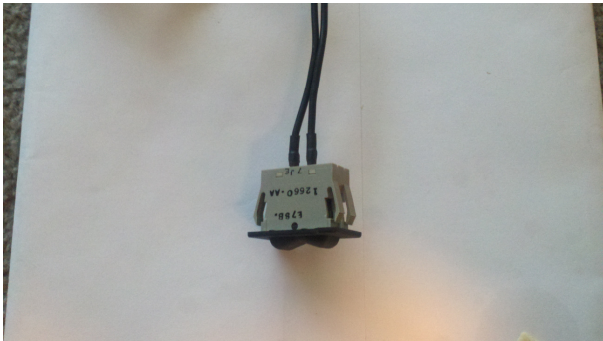
The switches are actually assembled as an outer shell, with the inner plastic switch mechanism. The inner mechanism is held in with plastic tabs molded into the plastic, which snaps into holes in the outer shell.

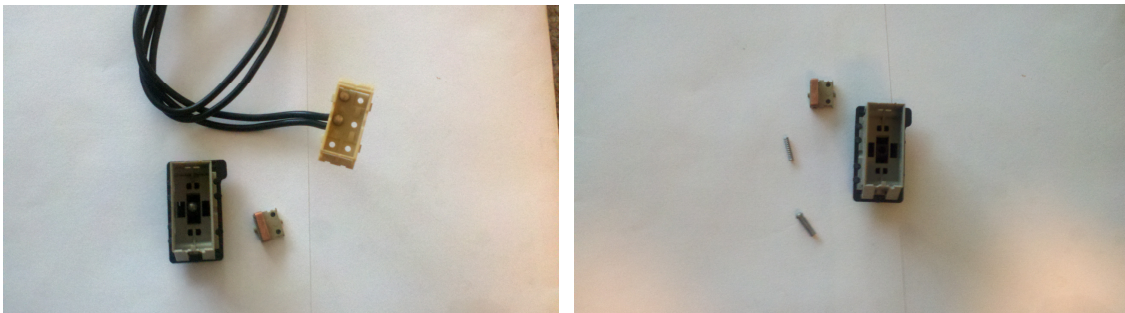
With a little teasing, you can actually pry the external shell away from the tabs, lightly pulling on the wires, and the interior switch mechanism will pop free. I used a fine tool pick, but a small straight blade jewelers screwdriver should work as well. This exposes the interior switch mechanism parts. The mechanism consists of the bottom piece with the contacts, a contacting plastic slider, and a small steel pin and spring. Be careful how you disassemble the switch. The spring sits under the rocker pin. If the switch is turned over, the pin and spring can fall out. There is no real need to remove the pin and spring.

Of the 3 switches that I opened, **ALL THREE WERE CORRODED** on the contacts. The contacts are silver plated copper. The slider that makes the connection is un-plated copper. I suspect that what happens is that due to dissimilar metals, over time the contacts start to corrode, causing a high impedance, and eventually an open connection. Whoever manufactured the switch did use some lubricant, but not enough or the right type.

The repair is easy. Using a small brass or bronze wire brush, clean the silver contacts and the copper slider. The secret is what to use to minimize future corrosion. Typically you

would use some electronic grade silicone grease. This grease is electrically neutral; however, it also is thick and heavy. This is what was originally used by the manufacturer. Instead, I used GC's Conductive Grease and Anti-oxidant. Unfortunately, this product is now discontinued, but there seems to be a lot still on shelves. A good alternative is Chemtronics CircuitWorks® Carbon Conductive Grease.

Apply a light coating of the grease on the silver contacts and on the copper wiper. Don't overdo it. It takes less than ½ cc to lubricate the mechanism.

Re-Assembly is straight forward. Place the plastic slider piece over the steel pin with the copper wiper up. Snap the rear plastic piece back into the outer shell, insuring that you are placing it back on such that the wiper is on the same side as the contacts and test the switch! It's entirely possible to "reverse" the operation of the switch, i.e. the "on" position will be off, the "off" position will be on. If this happens, just disassemble the switch and rotate the wiper and rear plastic 180° and put back together.
